Test Report

No.: SZXEC25001642110

Sample Name: Fuse(JFC1206-1200FS)

Halogen

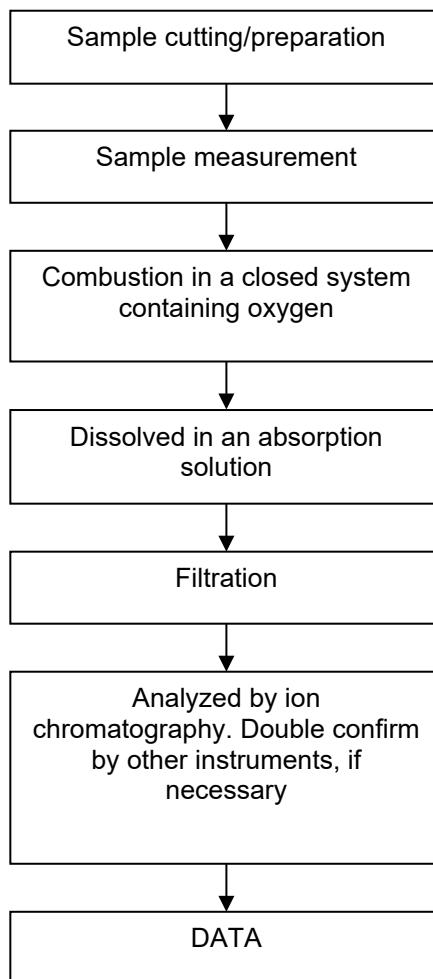
Halogen Testing Flow Chart

Test Method: With reference to EN 14582:2016, analysis was performed by IC.

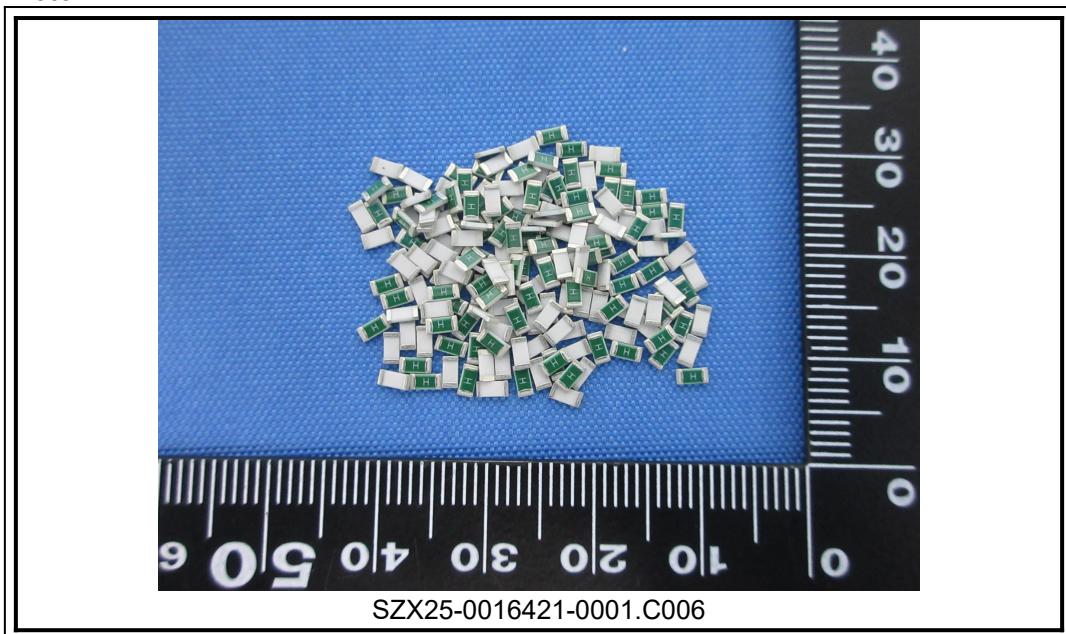
Sample Photo:

SN ID	Sample No.	SGS Sample ID	Description
SN1	A6	SZX25-0016421-0001.C006	"Fuse(JFC1206-1200FS) "
